Name Of Dam: GREENE MOUNTAIN LAKE DAM  
Location: GREENE COUNTY, VIRGINIA  
Inventory Number: VA. NO. 07915

# PHASE I INSPECTION REPORT NATIONAL DAM SAFETY PROGRAM

MAY 1981

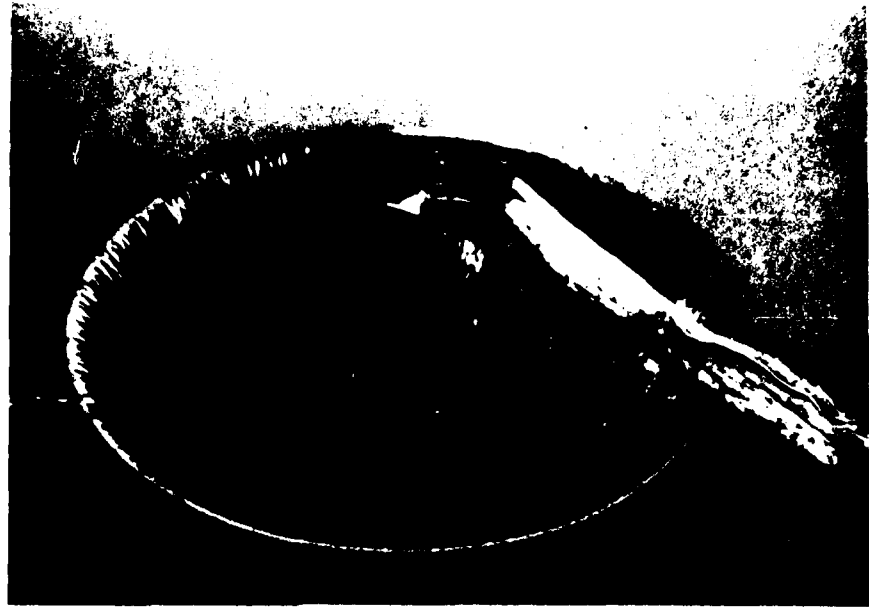
The riser structure showed no signs of deterioration and was functioning properly at the time of inspection. The outlet pipe had one open joint in the last section of pipe which was caused by severe erosion at the plunge pool. The last section of pipe has been stabilized by a concrete cradle, but the joint is open allowing water to run under the pipe. The slide gate has never been in use. The plunge pool was void of riprap and indicated erosion.

Photograph No. 3 - Intake Structure

It is recommended that the open joint in the outlet pipe be repaired. Also, that a trash rack should be placed on the intake structure and a staff gage be installed to monitor water levels.

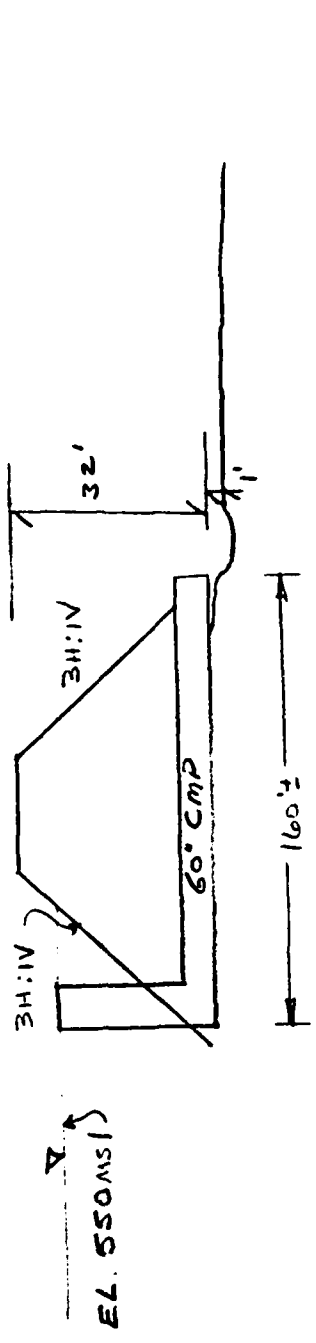
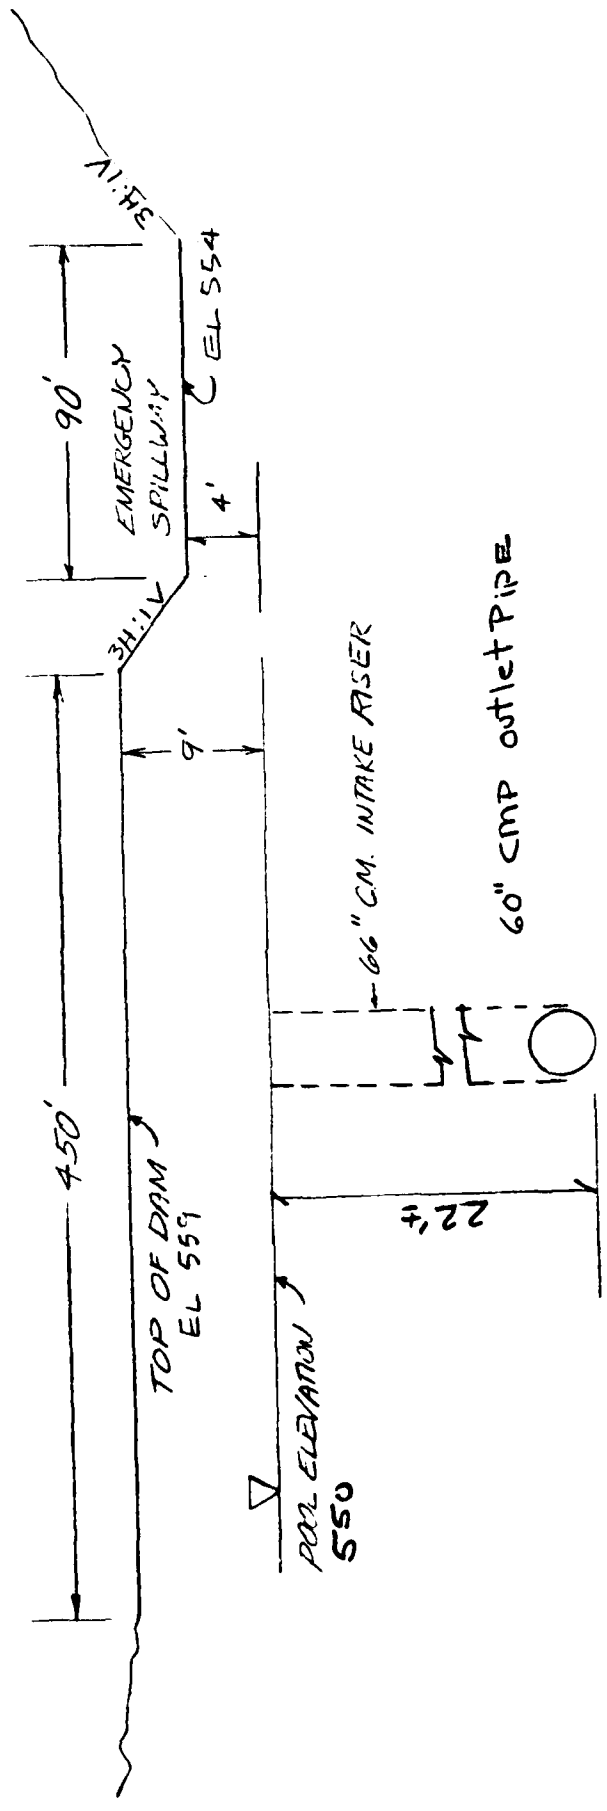
PROFILE  
GREEN MOUNTAIN LAKE  
FIELD SKETCH 2  
6 MAY 1981

PIPE JOINT LOOSE  
W/ 1" OPENING

7.3.5 The open joint in the outlet pipe should be repaired.

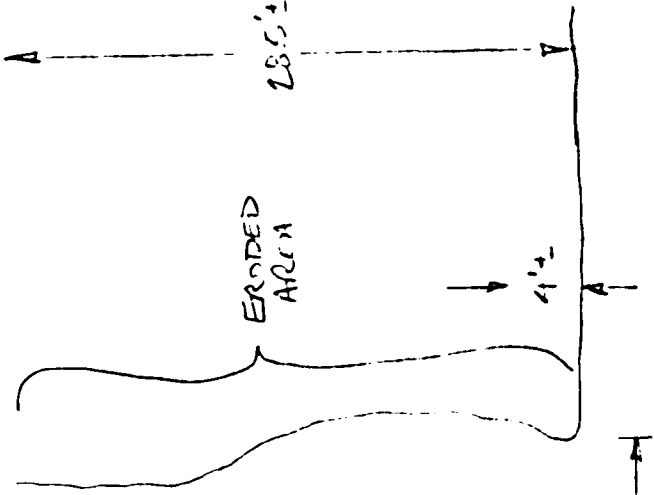
NOTE:  
THE EROSIONAL BULGE APPEARS TO BE  
THE RESULT OF EMBANKMENT SLOUGHING  
IT IS GRASSED OVER AND INCLUDES  
SEVERAL SMALL TREES AND BRICCS.

present on the upstream slope near the embankment crest and the two eroded areas along the emergency spillway discharge channel should be backfilled and reseeded. It is further recommended that the bulge or area of embankment sloughing present on the downstream slope 118 ft<sup>±</sup> to the left of the discharge outlet be regraded and reseeded. Vehicular traffic should be prohibited on the downstream slope and across the embankment crest. It is recommended that the crest be reseeded.

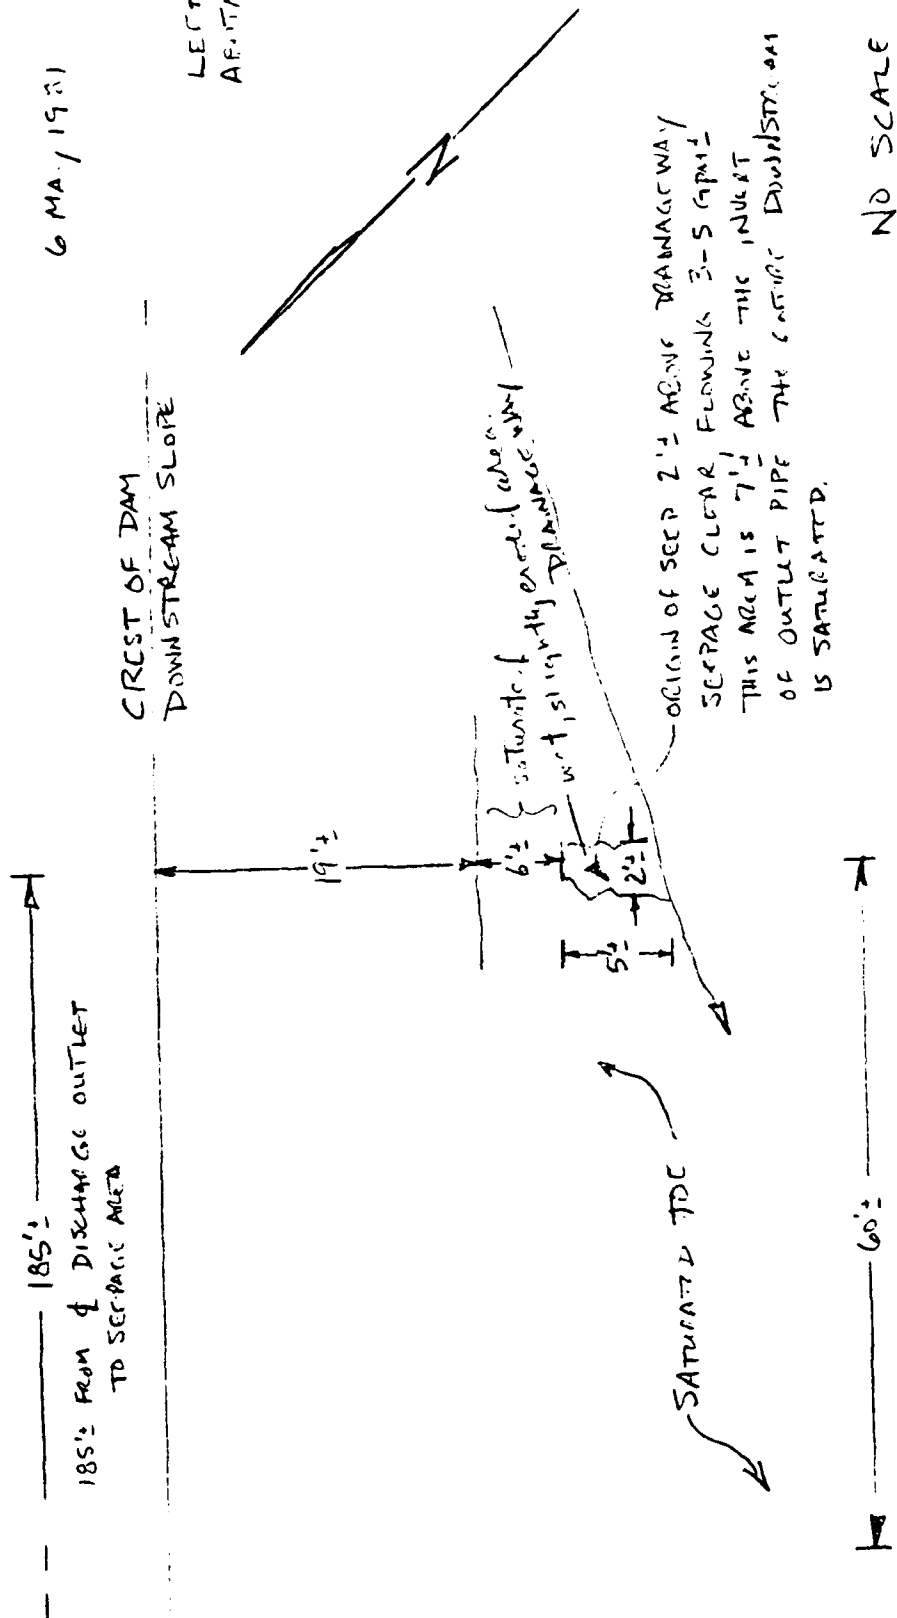
SKETCH 4

The basal 4 ft<sup>+</sup> of the downstream toe, extending from the discharge outlet to the left abutment is saturated. During the May 6, 1981 inspection flow estimated at 3 to 5 gpm was flowing from the center of a 2 ft<sup>+</sup> wide and 5 ft<sup>+</sup> long, wet and eroded area located near the left downstream toe, left abutment contact. Flow was clear and there was no iron staining. Details are provided on Field Sketch 4, Appendix III. On June 16, 1981, no flow was observed from this area.

The saturated ground existing along the downstream toe and the area of intermittent flow are believed to be related to seepage through the dam. This does not necessarily create an unsafe condition; however, these areas should be monitored periodically in attempt to detect any significant future flow which may result in piping within the embankment.

A PLATFORM 2-7'± HIGH EXTENDS OFF  
THE LEFT ABUTMENT NEAR SEEPAGE FLOW.  
THE PLATFORM IS 20'± WIDE. MAY HAVE  
BEEN A CONSTRUCTION RAMP.

7.3.10 The saturated downstream toe and area of intermittent flow described in Field Sketch 4, Appendix III should be monitored quarterly to detect any increase in flows. If increased flows should occur, a Professional Engineer with expertise in Geotechnical Engineering should be contacted to evaluate the problem and make recommendations for required corrective measures.
